# Our Mother of Sorrows Grotto

on the campus of Mount Mercy University

Cedar Rapids, Iowa

William Lightner's  
Our Mother of Sorrows Grotto Preservation  
and Restoration 2010-2014

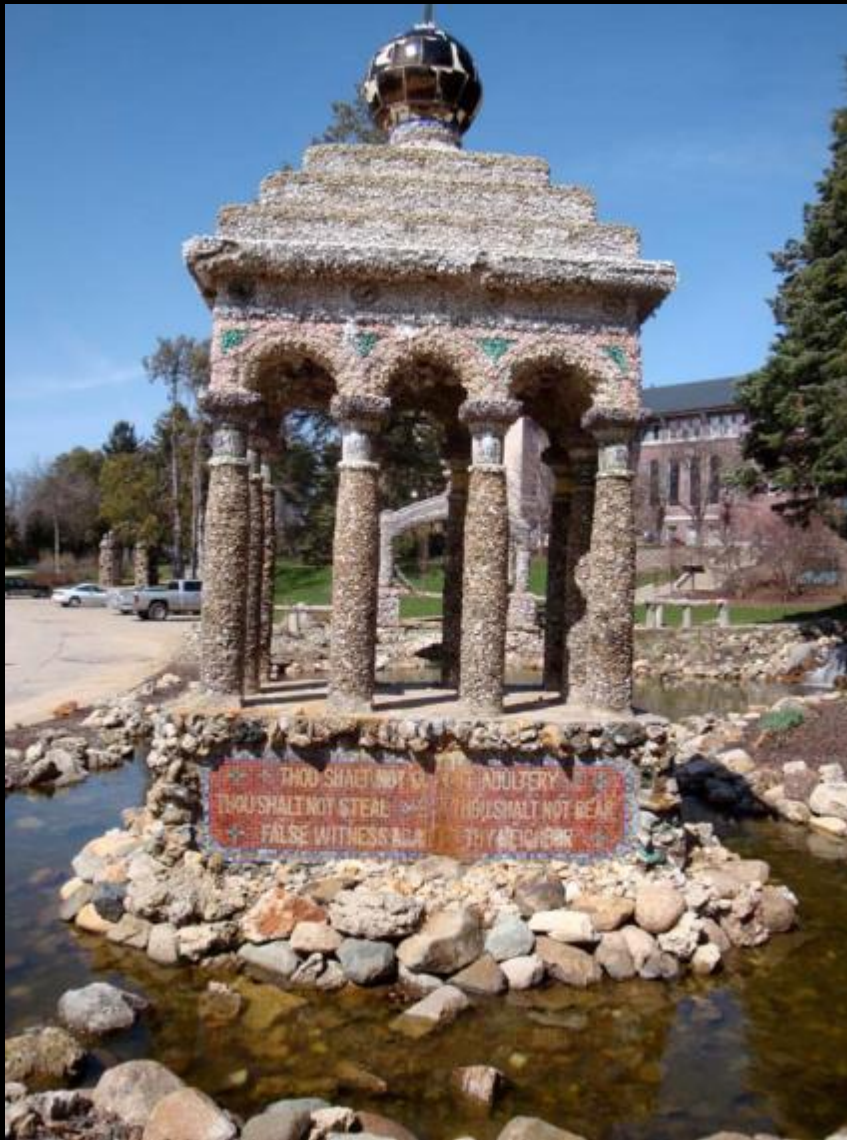
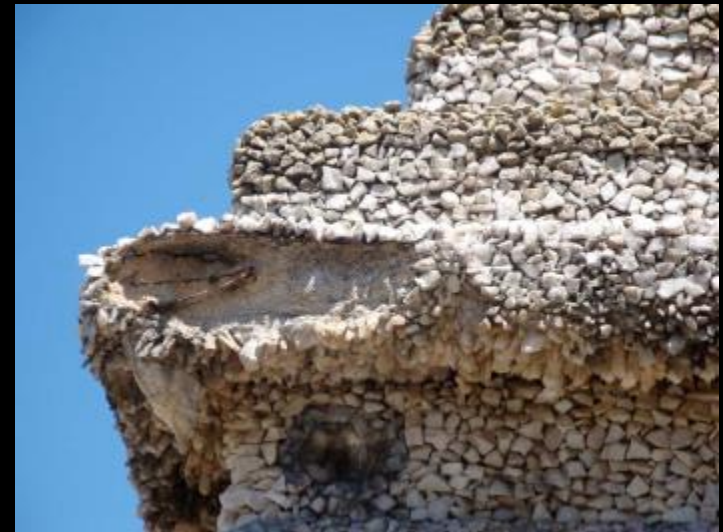
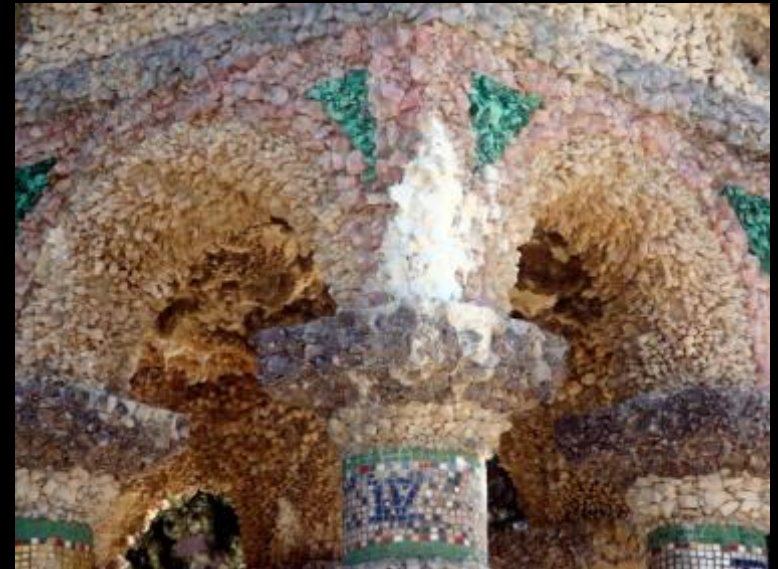
- Above left note rust stains on mosaic as well as poor condition of temporary replacement globe. To the right see calcification efflorescence and missing mortar and stone on roof.

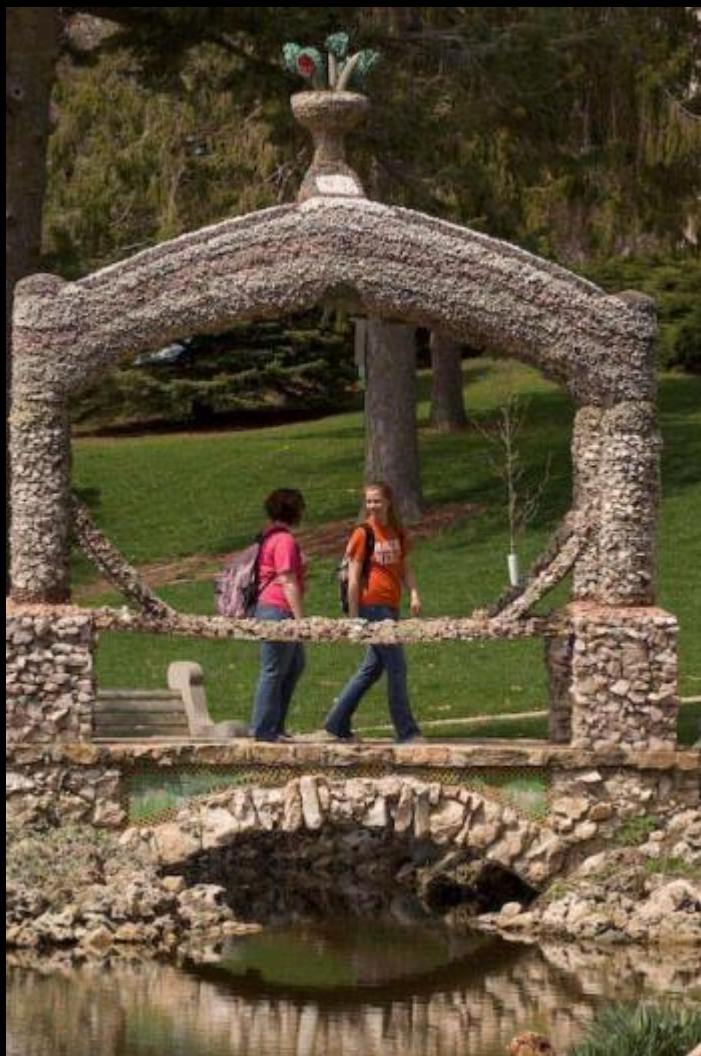
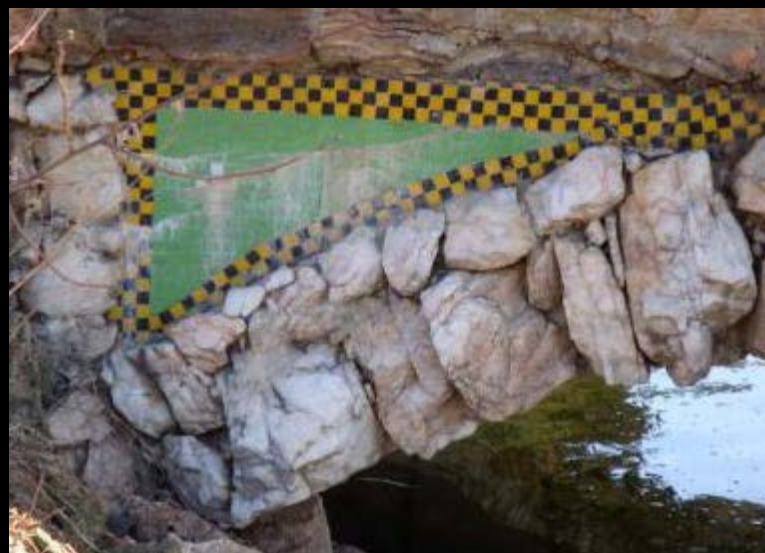
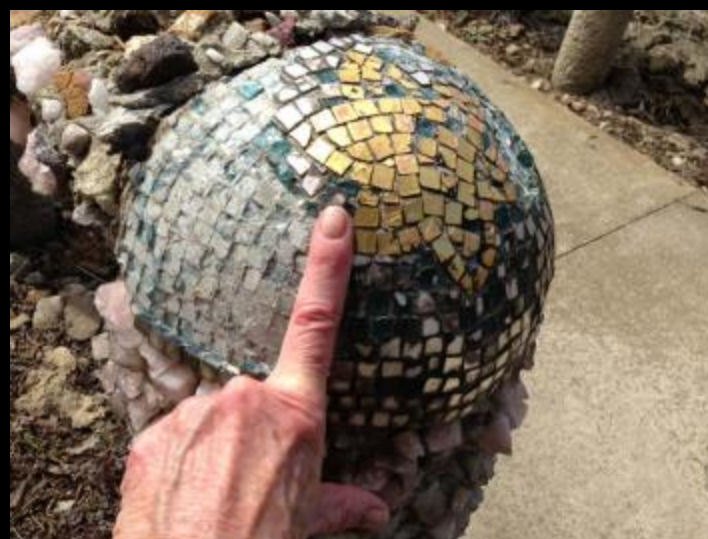
- Note deteriorating mosaic on lower arch above water and missing Italian mosaic tiles on railings.

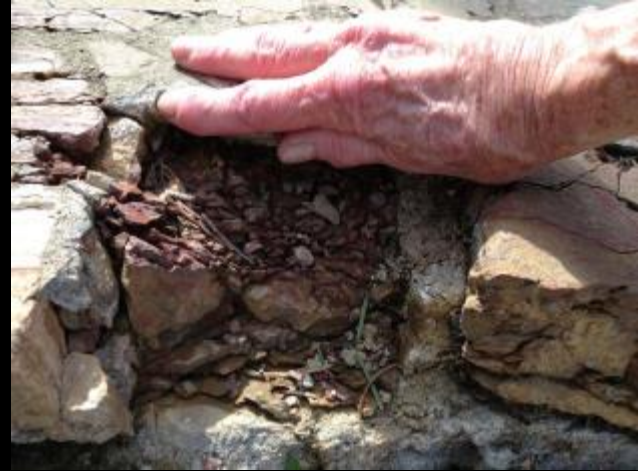
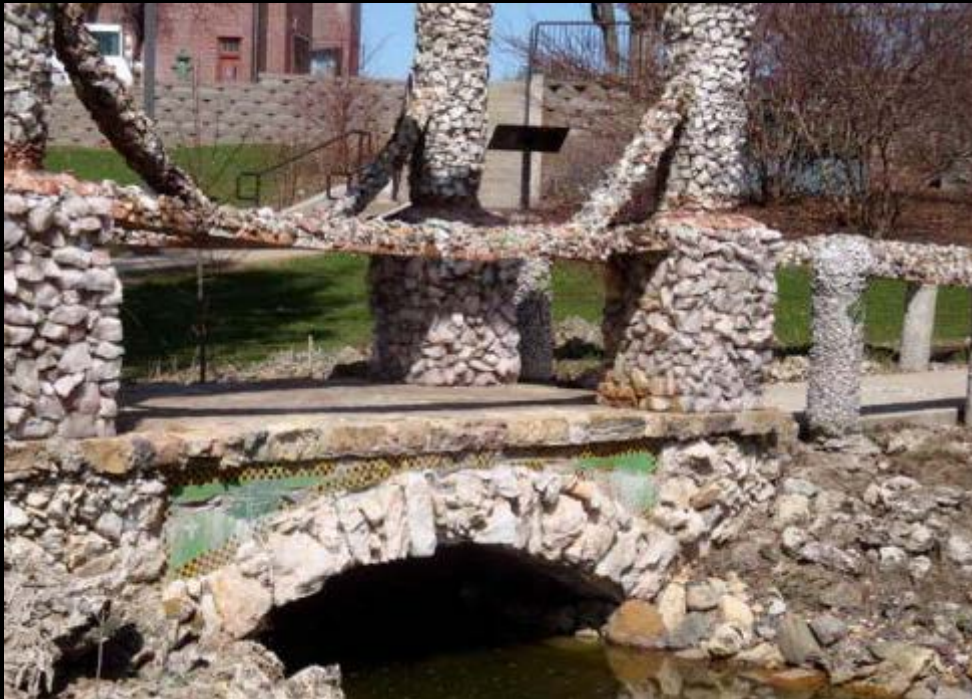
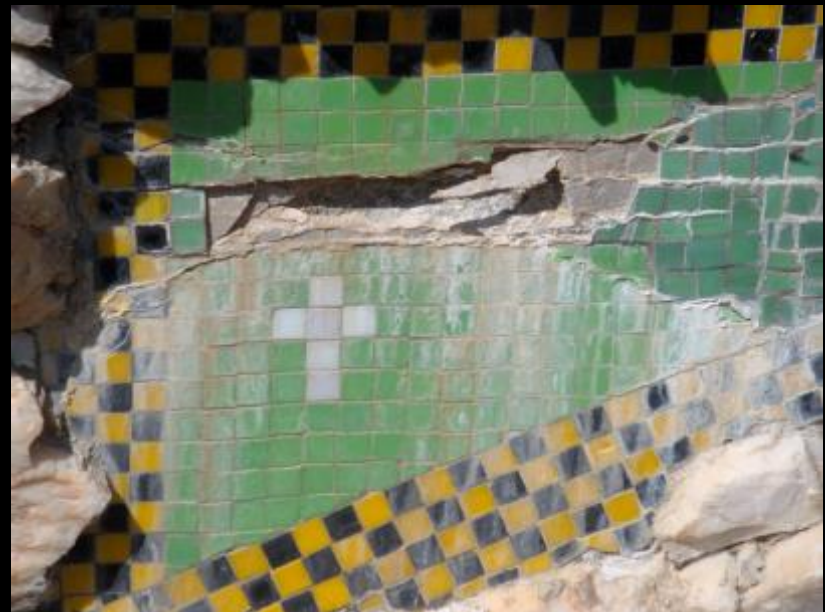
# The BRIDGE: before

Note the serious deterioration of mortar and stone on the bridge deck floor and the cracking and loss of tiles on the arch under the deck (both sides). Many of the original stones are missing from the Bridge railings as well

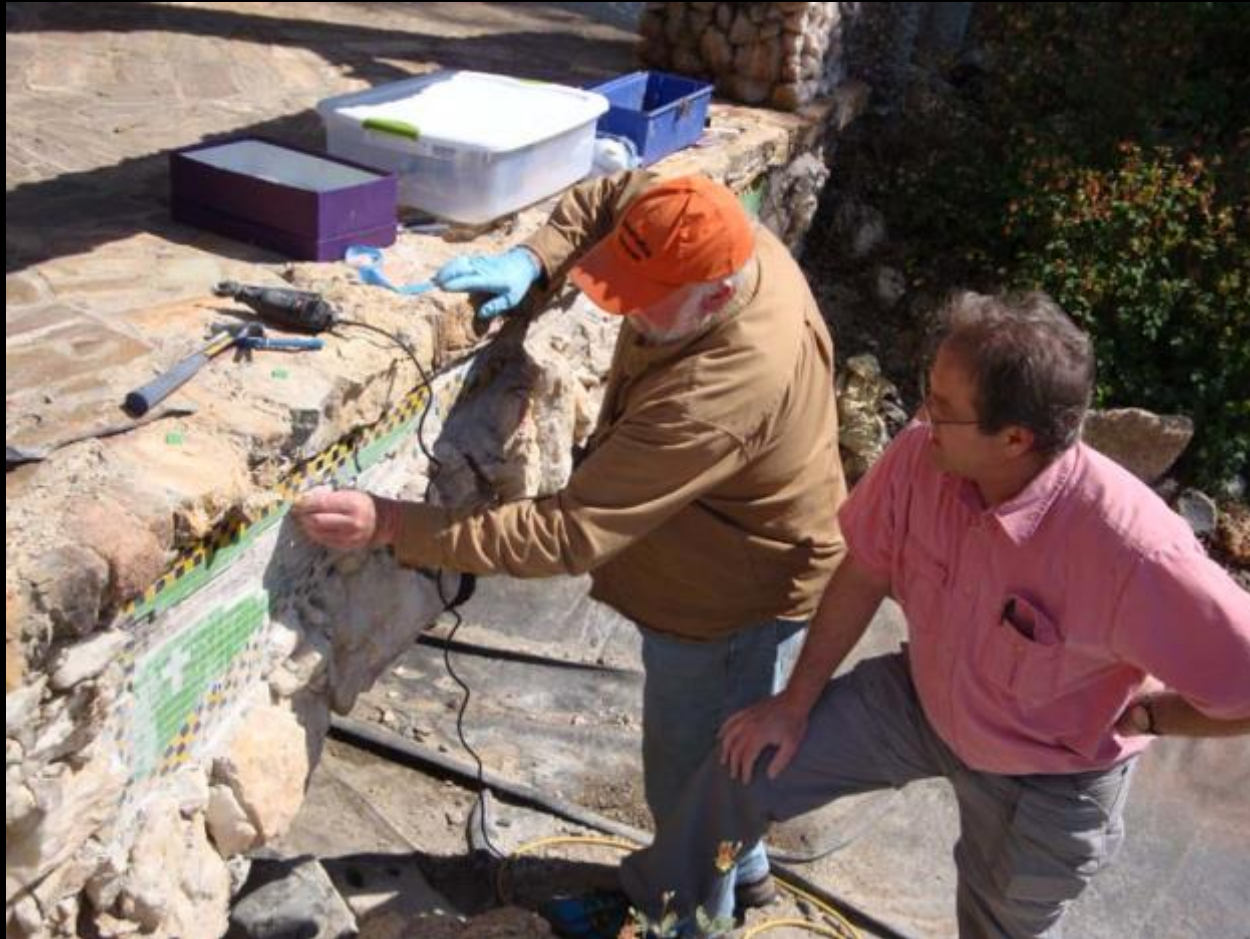
Conservator Don Howlett and trained Assistant David Van Allen inspect damage to mosaics on lower arch of bridge
